**Report For:**  
Dudley Pond Association  
Wayland, Massachusetts

## Dudley Pond Aquatic Macrophyte Survey - 2020

**Prepared by:**  
**Aquatic Restoration Consulting, LLC**  
18 Sunset Drive  
Ashburnham, MA 01430

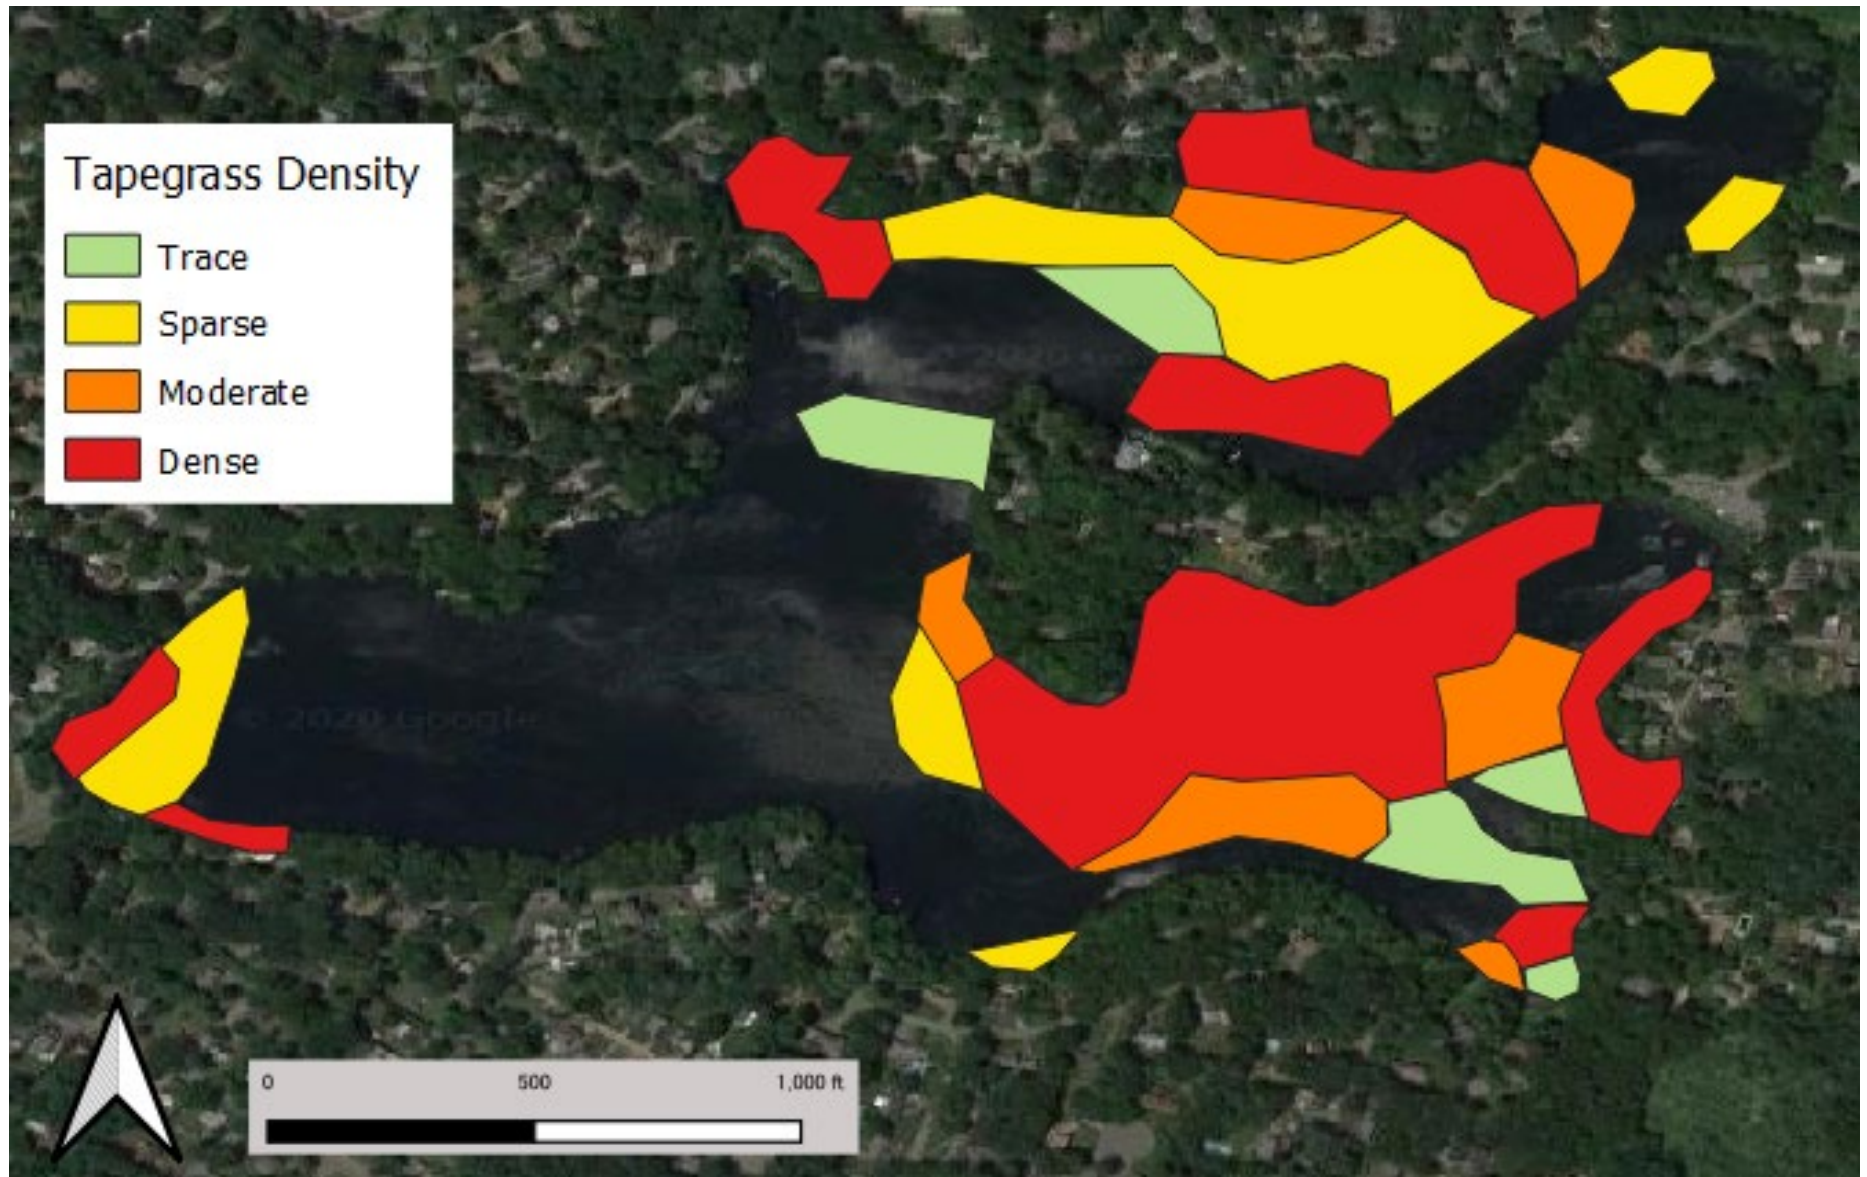
**Figure 4. Dudley Pond Tapegrass Density (Sept. 2020)**

Plant species richness (number of species encountered) was low, especially at any given point. On average, each location contained just two different species. Slender naiad (also known as nodding water nymph; *Najas flexilis*), was the most frequently encountered plant during the September 2020 survey (90% of the survey points with plants), followed by tapegrass (71%). When present, tapegrass was typically dense (54% of locations Figure 4). Slender naiad and tapegrass were commonly encountered together. Filamentous green algae were also widely distributed but the overall density was relatively low. EWM was encountered at only four locations and at low densities (Figure 5).

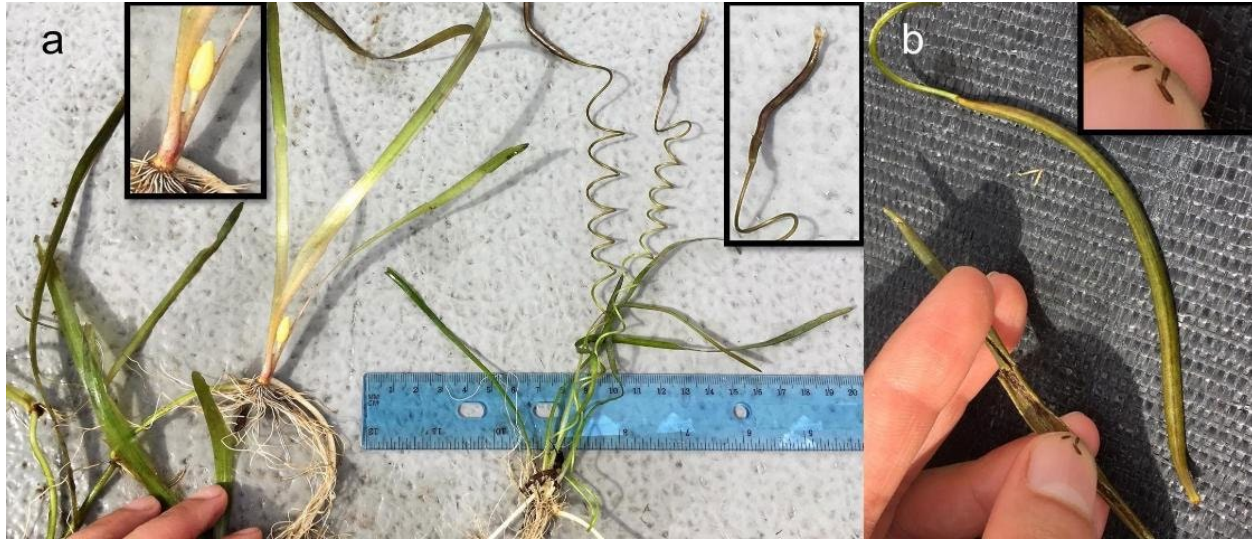
**Figure 6. Tapegrass Sexual Reproductive Structures.<sup>2</sup>**

a) Tapegrass (*Vallisneria americana*) staminate flower on the male plant on the left, and seedpod on the female plant on the right. b) Seedpods carry hundreds of tiny seeds, which are about 1.6 mm or 1/16 of an inch in size.<sup>2</sup>
